# KENTUCKY TRANSPORTATION CENTER

**MAINTENANCE PAINTINGS OF  
VARIOUS BRIDGE PROJECTS  
DURING 2001-2002  
Kentucky Highway Investigative Task #42**

**Research Report  
KTC-03-04/KH42-01-1F**

**Maintenance Painting of Various  
Bridge Projects During 2001-2002**

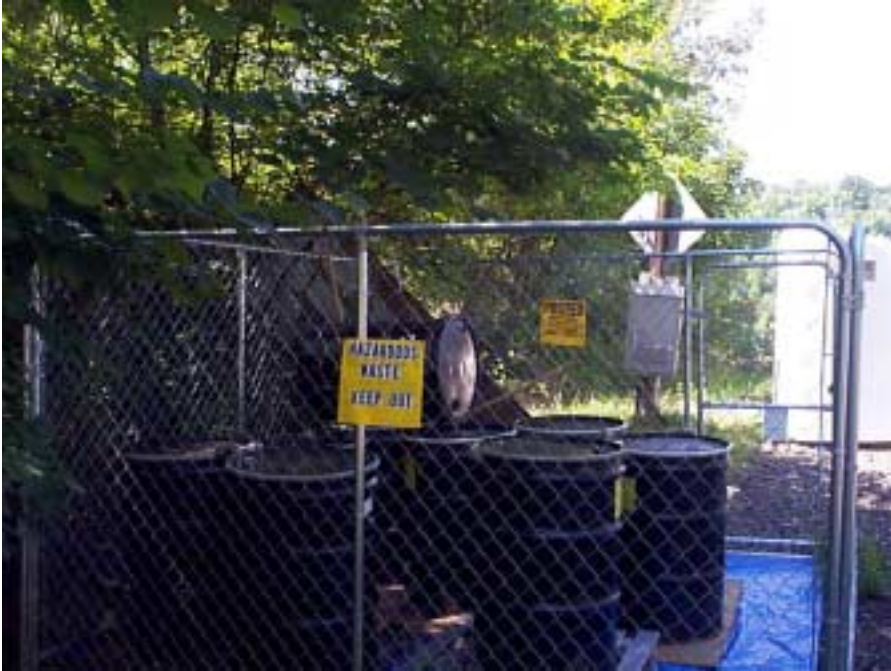
Figure 77. The hazardous waste storage site for the KY 80 Bridge.

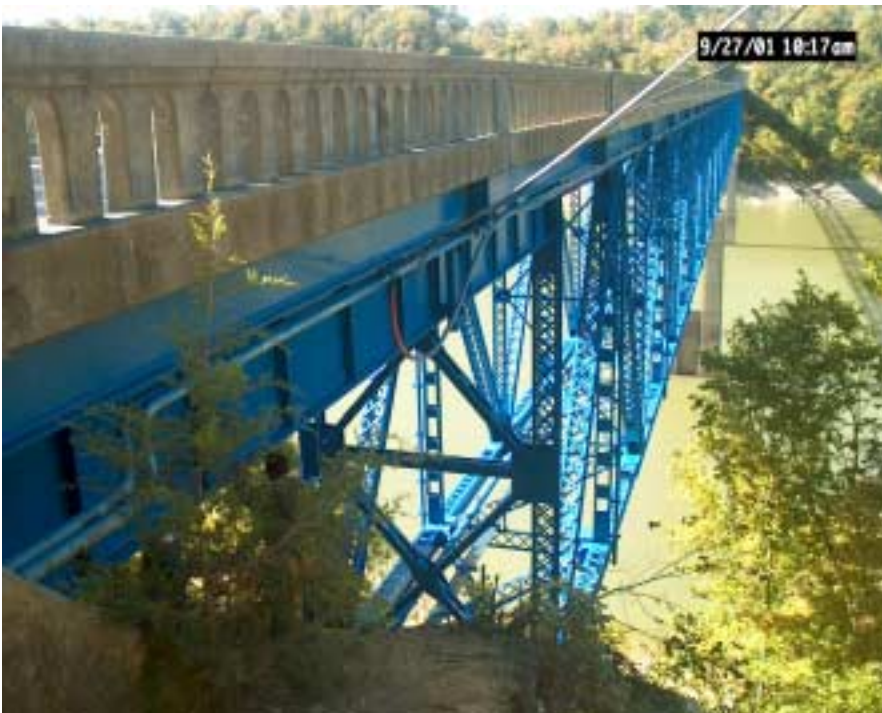
Figure 78. View of the KY 80 Bridge after painting.

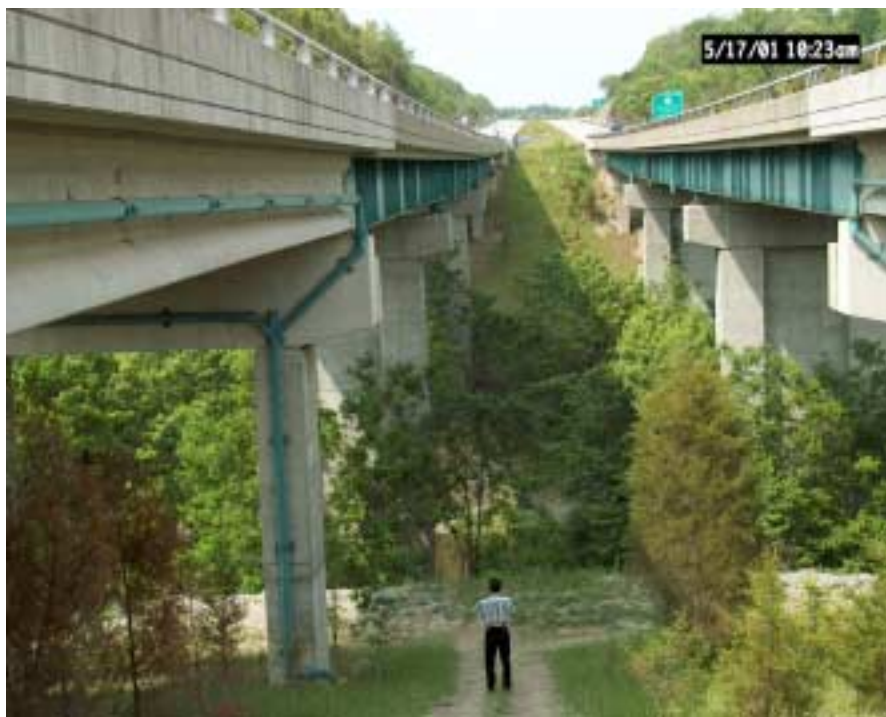
Figure 79. View of KY 9002 Bridge in Washington County before painting.

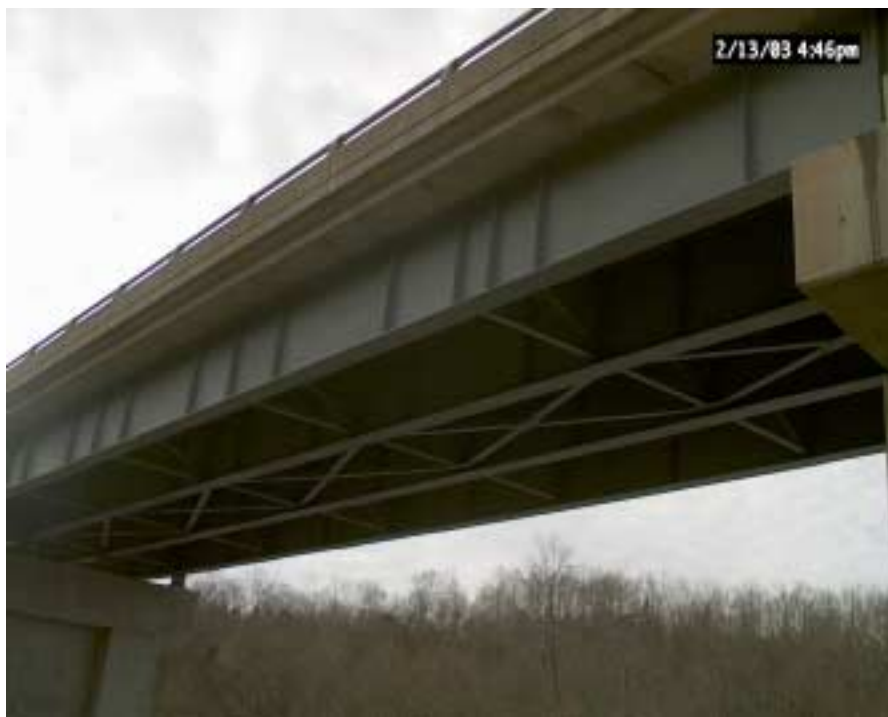
Figure 81. View of KY 9002 Bridge in Washington County after painting.

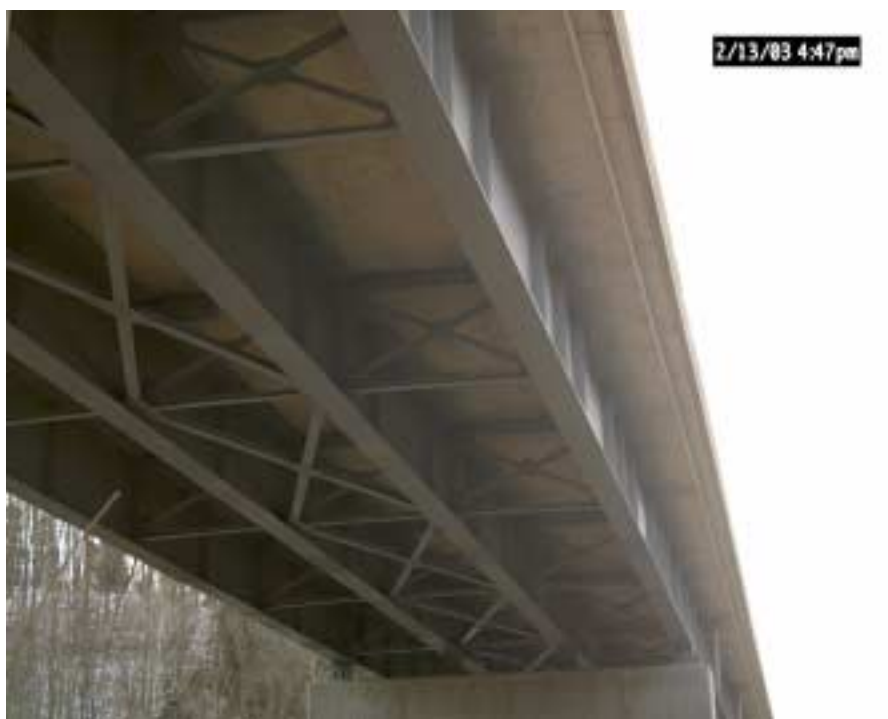
Figure 82. View of under side of KY 9002 Bridge in Washington County after painting.
